Soils and Foundations

# Lessons for countermeasures using earth structures against tsunami obtained in the 2011 Off the Pacific Coast of Tohoku Earthquake

Ken-ichi Tokida, Ryusuke Tanimoto

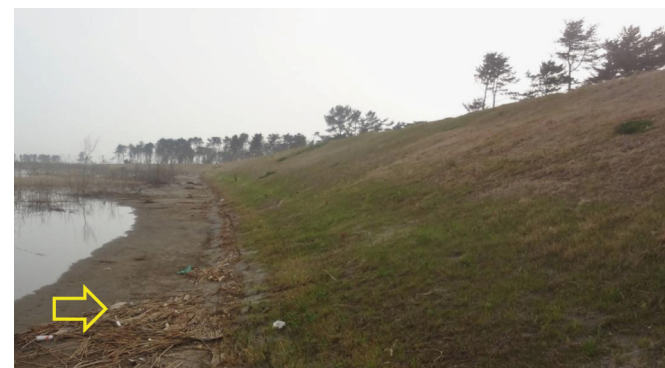
Photo 2. Front slope after tsunami on May 2 (Idoura).

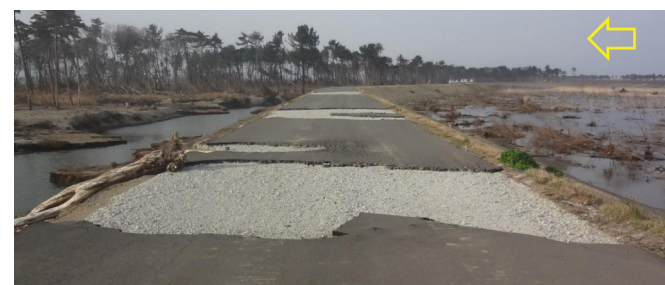
Photo 3. Crest after tsunami on May 2 (Idoura).

The levee, indicated by a circle in [Photo 1](#), is approximately 100 m long. It eroded and approximately a depth of 1 m of the crest was washed away by the concentration of tsunami flow. Nonetheless, the whole stability of the levee was maintained.

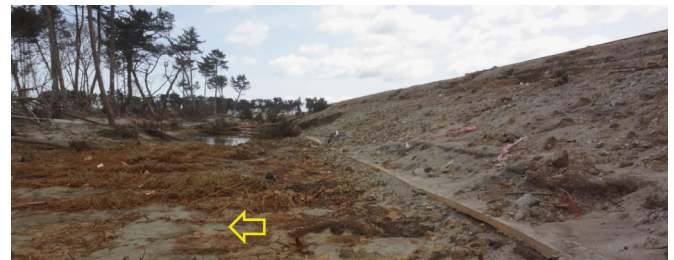
[Photo 4](#) shows the erosion at the back slope and the toe due to the tsunami; it indicates that the erosion at the back side of the levee is more severe than that at the front slope and the crest. [Photo 5](#) shows a water pool eroded by the flood stream (such a pool is henceforth referred to as a ‘dug pool’) and a slope failure. The failure level, in terms of the level of performance reduction from the engineering viewpoint, appears to be low.

Photo 4. Back slope after tsunami on May 2 (Idoura).

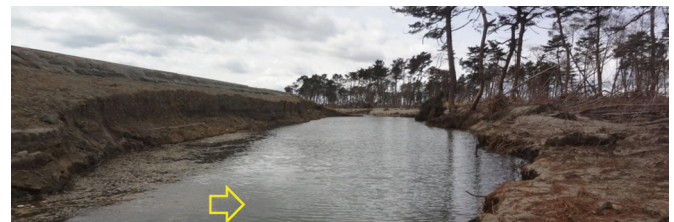
The dug pool shown in [Photo 5](#) is clearer in the satellite image in [Photo 6](#). It is seen that the forest located behind the dug pool was not completely washed away, but remained after the tsunami. On the other hand, it is interesting to note that the forest at the back side of the levee, where there is no dug pool, no longer exists; it was washed away by the tsunami flood-water. This observation on the difference in damage level of the forest represents an important lesson and implies that dug pools are effective in reducing the force of a tsunami.

Photo 5. Dug pool and slope failure on May 2 (Idoura).

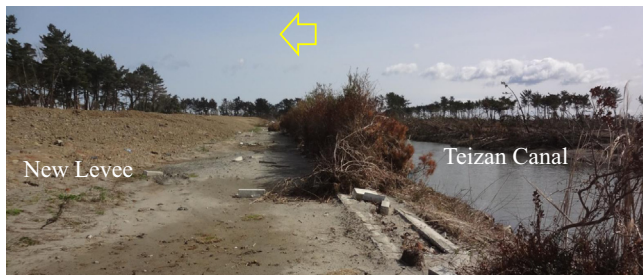
As shown in [Photo 8](#), the new reinforcing levee, approximately 2.1 m high, exists on the bank of the Teizan Canal. Although the lawn planted on the front slope was washed away

Photo 8. Eroded new levee on April 30 (Higashiura).

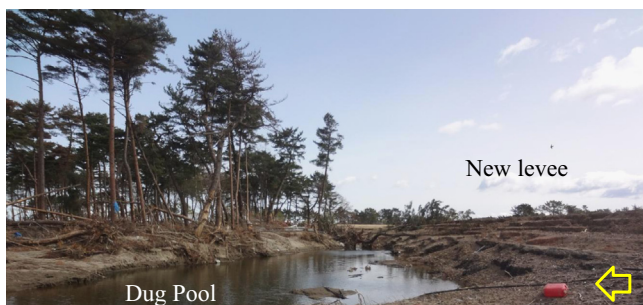
Photo 9. Back slope after tsunami on April 30 (Higashiura).

by the tsunami, the erosion is limited to the surface. Moreover, as shown in [Photo 9](#), the back slope is also eroded only on the surface and the dug pool can be clearly seen. Nonetheless, the performance of the levee is maintained.

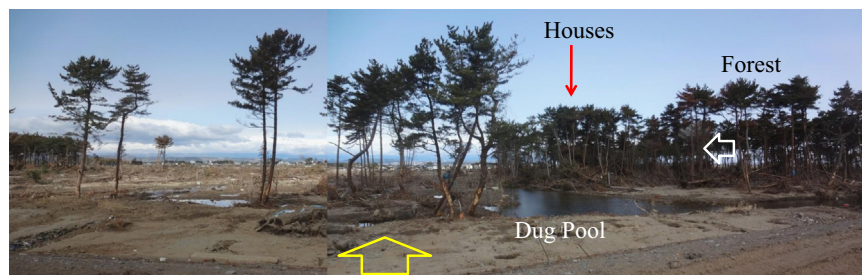
Photo 10. Comparison of eroded background of levee with uneroded background on April 30 (Higashiura).

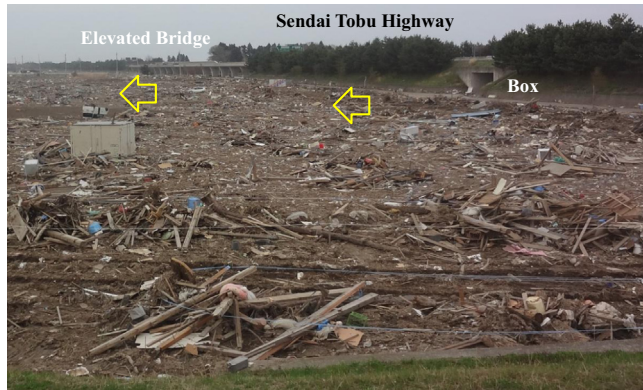
Photo 12. View on mountain side of embankment on April 30 (Takenohana).

high with the slope toe reinforced with concrete blocks. The embankment was flooded, and the flooded depths measured at the sea side and the mountain side are 1.9 m and 1.15 m, respectively. The flooded height at the mountain side appears to be almost two thirds that at the sea side. In addition, the debris swept away on the sea side around the embankment, shown in [Photo 13](#), appears to be similar to or a little worse than that on the mountain side, as shown in [Photo 12](#).

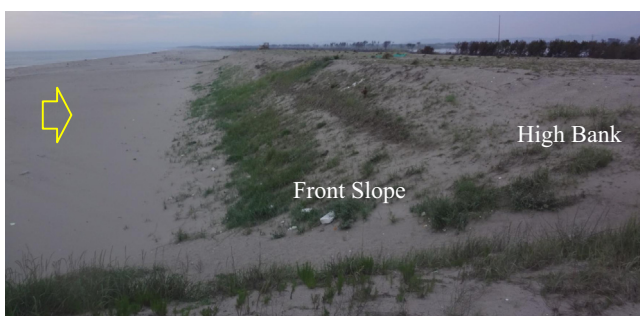
On the other hand, [Photos 17](#) and [18](#) show the conditions of the front and the back slopes of the bank, respectively, and indicate that both slopes were slightly eroded by the tsunami. [Photo 18](#), in addition, shows on back side the existence of a low bank, which is 1.6 m high and 12.8 m in base width. The surface of this low bank is not eroded, as shown in the photo. This is attributed to the flood reduction by the high front bank.

Photo 17. Front slope of bank on July 9 (Yuriage).

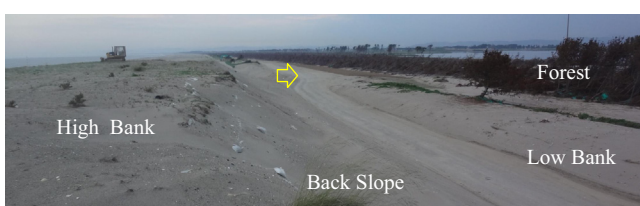
Photo 18. Back slope of bank and background on July 9 (Yuriage).

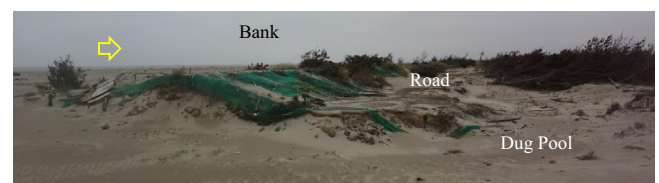
[Photo 20](#) shows a low bank located approximately 900 m from the bank of Example 4. A section of this bank is shaped like a triangle with a height of 1.5 m and front and back slopes of approximately 1: 7.3 and 1: 2.7, respectively. The slope surface is covered with grass and pine trees, as shown in [Photo 21](#). The surface layer is reinforced with nets installed to

Photo 20. Eroded low bank and dug pool on September 11 (East Yuriage–East Airport).

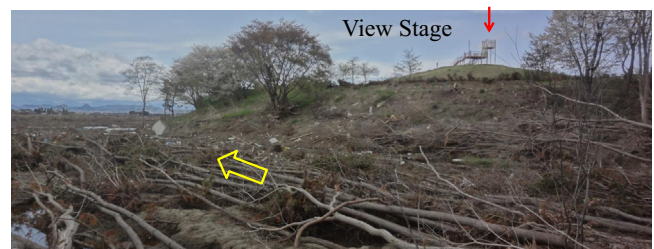
Photos 25 and 26 show the eroded conditions on May 2 on the side and at the front of the bank after the tsunami, respectively. The slopes of both sides are 1: 4–1: 5 and/or similar to the slope of the river levee; each side is eroded slightly. Photo 27 clearly shows the erosion of a walkway at the front of the bank. It is seen that the damage level is low and can be repaired easily; there is no geotechnical problem.

Photo 25. Side of bank blown around by tsunami on May 2 (Boken Plaza).

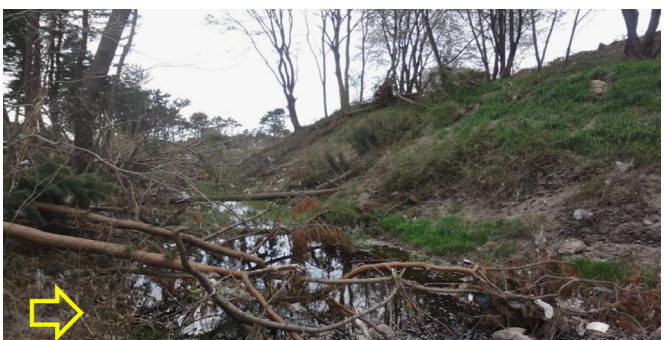
Photo 26. Front slope facing sea side of bank on May 2 (Boken Plaza).

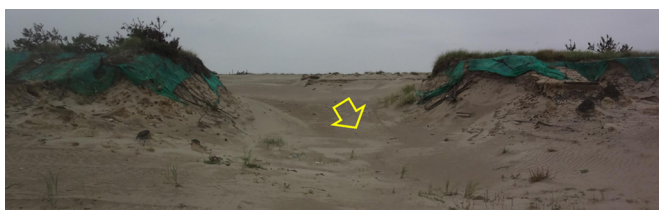
Photo 22. Eroded and washed away section of low bank on September 11 (East Yuriage–East Airport).

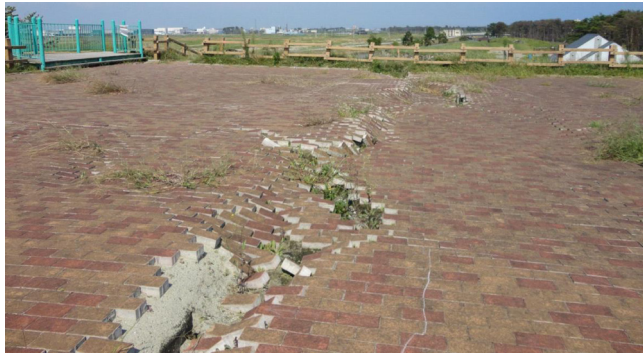
The top stage is paved with blocks and has been settled and cracked, as shown in [Photo 33](#), because of the seismic ground

Photo 33. Cracks at top of high bank on September 12 (Iwanuma Coastal Green Zone).

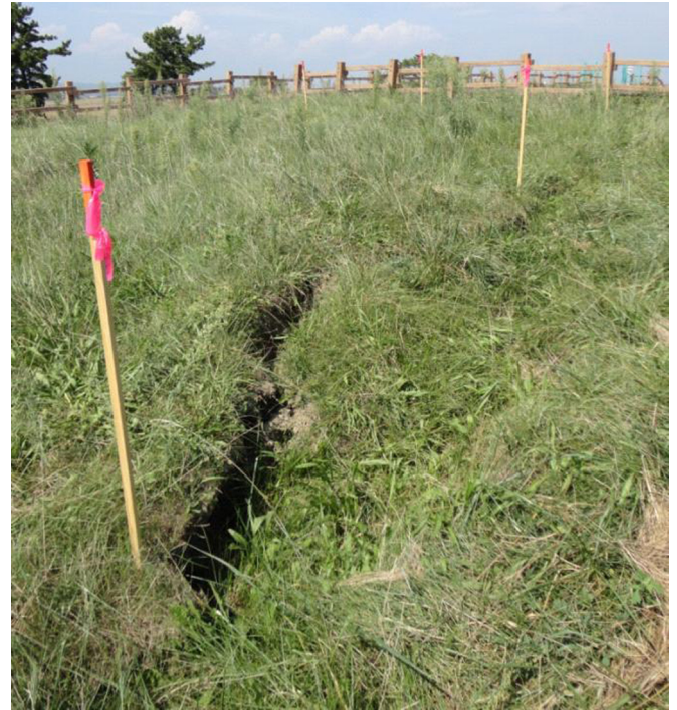
Photo 34. Cracks on south slope on September 12 (Iwanuma Coastal Green Zone).

motion before the tsunami attack. The cracks can be clearly observed in the slope shown in [Photo 34](#), and soil liquefaction can also be confirmed because traces of sand boiling can be seen at the lower side of the slope, as shown in [Photo 35](#).

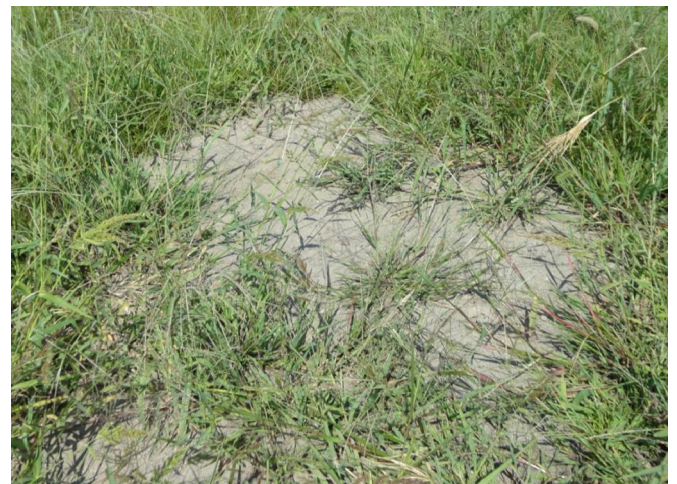
Photo 35. Trace of sand boil on September 12 (Iwanuma Coastal Green Zone).

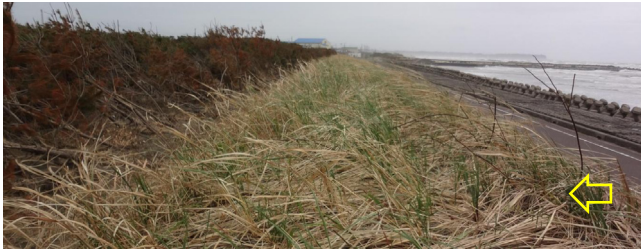
[Photo 36](#) shows the condition at the crest of the bank on April 23 and reveals that the crest was not eroded and the surface of the planted bank could be protected against the shallow overflow of about 0.5 m deep. [Photo 37](#) shows trees planted at the back side of the bank, these trees are tilted a little

Photo 36. Crest of bank by low overflow on April 23 (East Ashikawahama).

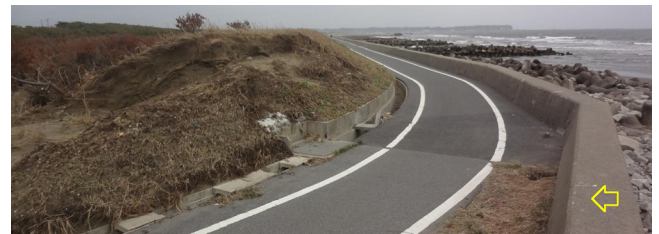
Photo 40. Eroded edge at river mouth on April 23 (Nishiashiarai).

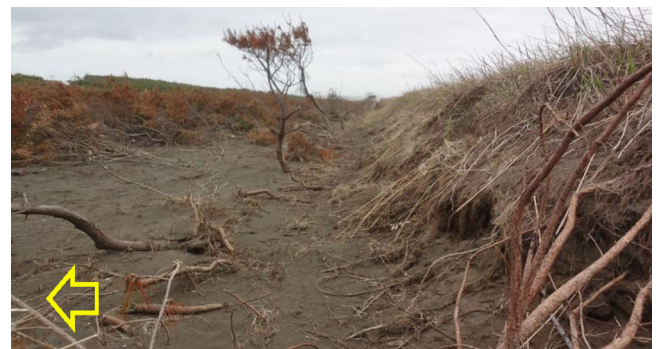
Photo 41. Trees eroded at toe of back slope on April 23 (Nishiashiarai).

Photo 41 shows the eroded condition at the back slope of the bank. It can also be seen that the back slope, the back toe, and the back ground are slightly eroded. It is may be concluded, therefore, that a 2-m-high bank can resist a 1-m-deep overflow from the 1.2-m minimum overflow depth mentioned above.

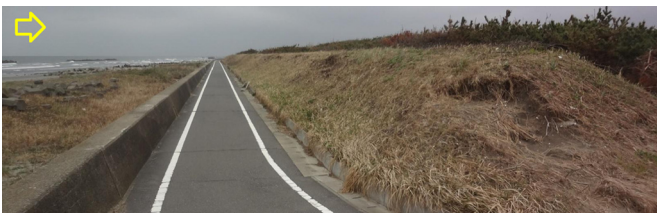
Photo 43 shows the front slope of the bank whose crest is 2.5 m wide and back slope is 2–1.5 m high. It is estimated that the lower edge of the sea wall is approximately 0.9–0.4 m high above sea level. Since the tsunami swept over the bank shown in Photo 43, the tsunami height can be estimated as greater than 4.5 m. Thus, the estimated overflow depth is approximately 0.5–1 m, as shown in Table 1. This estimate takes into account the eroded condition shown in Photo 44 and other conditions.

Photo 43. Front slope erode by low overflow on April 23 (Mikawa).

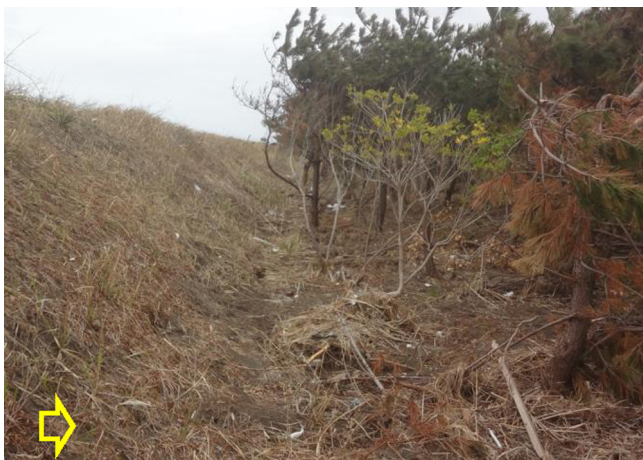
Photo 44. Back slope eroded by low overflow on April 23 (Mikawa).

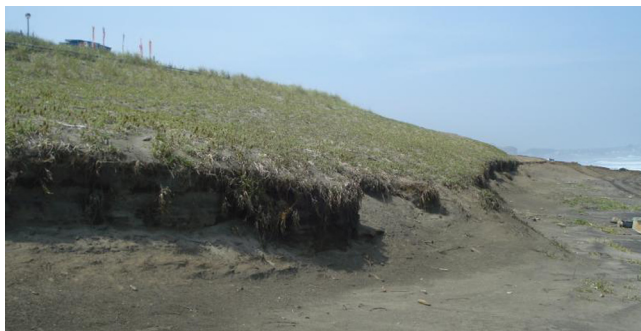
Photo 49. Plant zone eroded by tsunami on June 4 (Oarai Coast).

on the steep one. Photos 49 and 50 show the eroded condition at the lower part of each sand dune. The erosion shown in these photographs was most likely experienced because of the tsunami in this earthquake. However, the maximum height of the eroded zone appears to be approximately 1 m, this could not induce a severe slope failure.

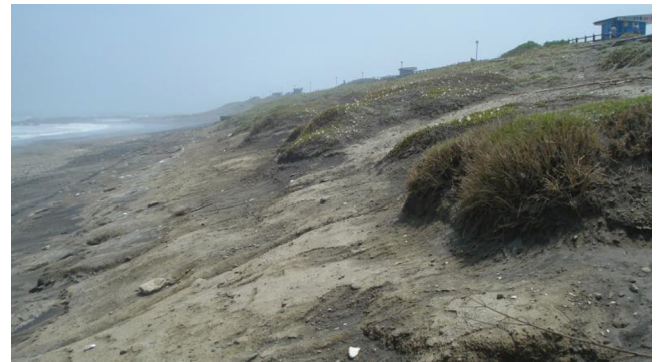
Photo 50. Lower part of slope eroded on June 4 (Oarai Coast).

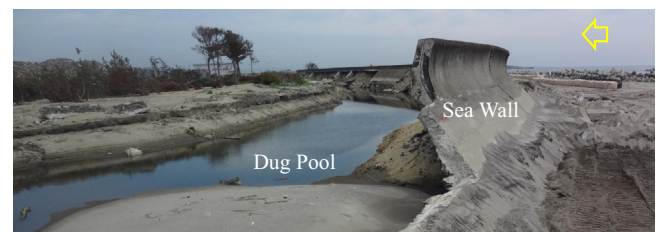
Photo 51. Dug pool at background of concrete sea wall at Arahama Kita on July 9.

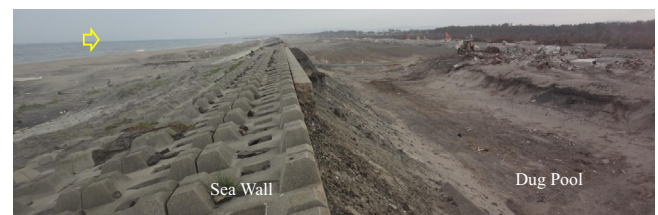
Photo 52. Dug pool at background of block-laid sea wall at east-side of Sendai Airport on July 8.
